MERRITT &amp; HARRIS, INC.

20-251E

Re: **World Trade Center**  
**New York, New York**

One World Trade Center

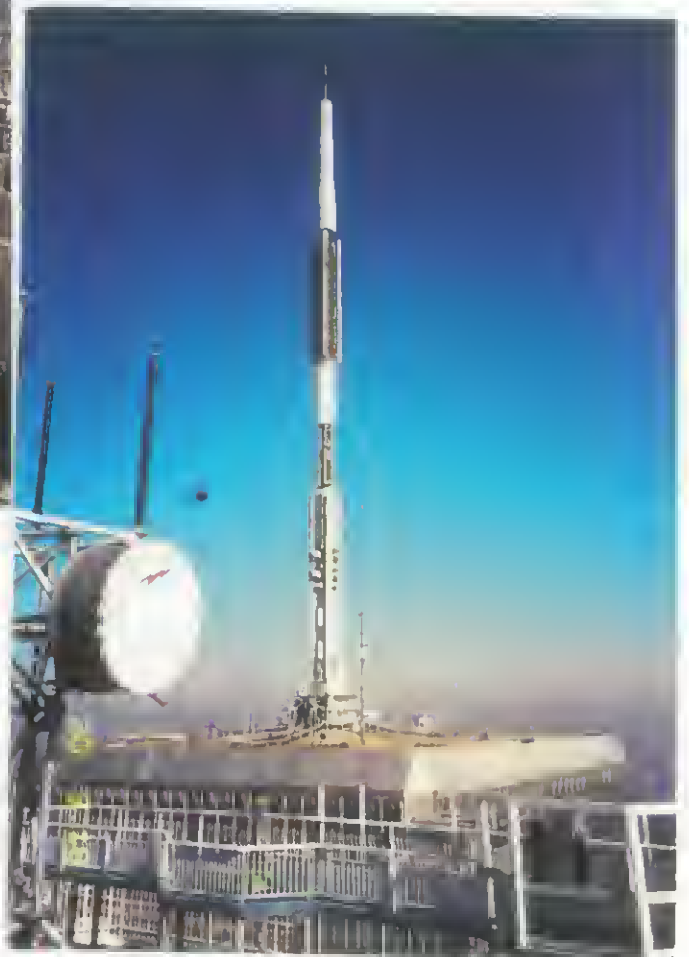
Photograph 4

Antenna

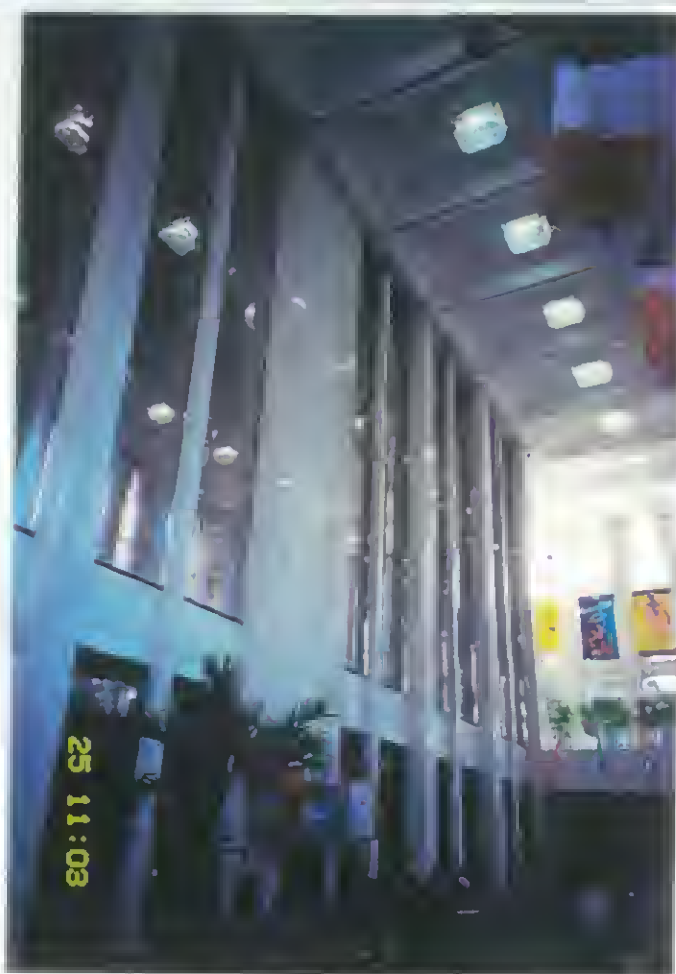
Photograph 8

Lobby and elevator  
banks

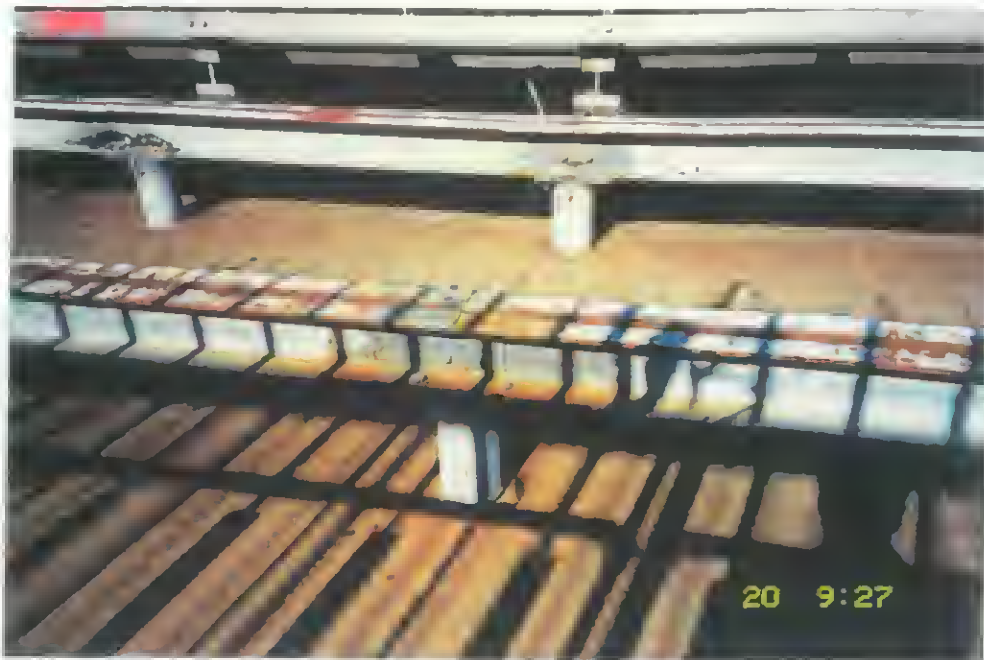
Photograph 7

Rusted window  
washing rig rails

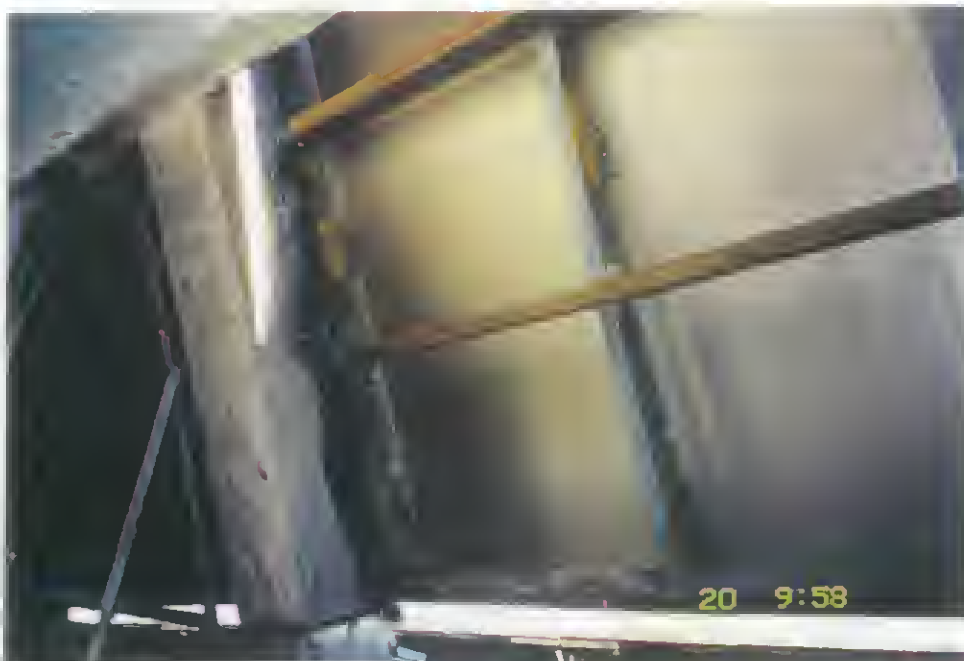
Photograph 8

Rusting purlins for  
exposed facade at  
110-story and at  
roof

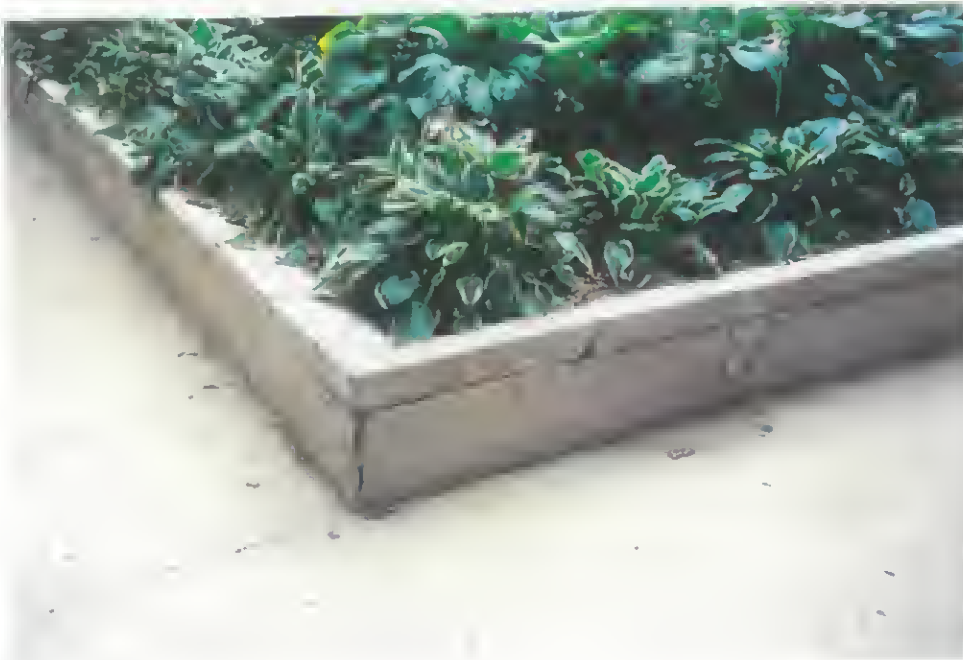
Photograph 16

Planter damage  
at Plaza level  
near 4 WTC

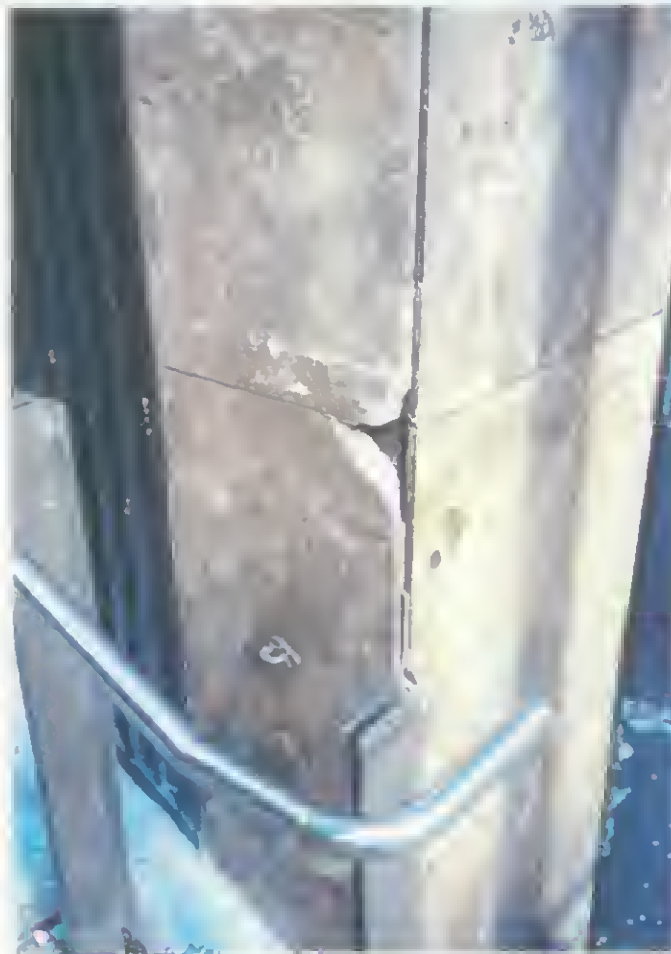
**Photograph 27**

**Example of  
displaced marble  
panels to be  
monitored for  
further  
movement**

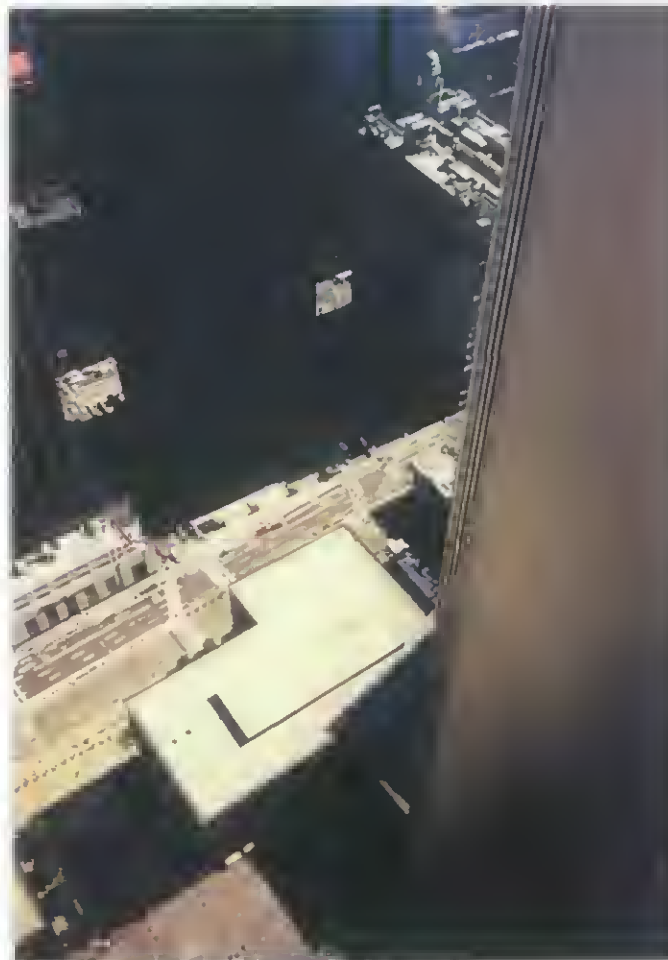
**Photograph 13**

Detail of sill  
condition at 4th  
floor where  
painted finish is  
failing

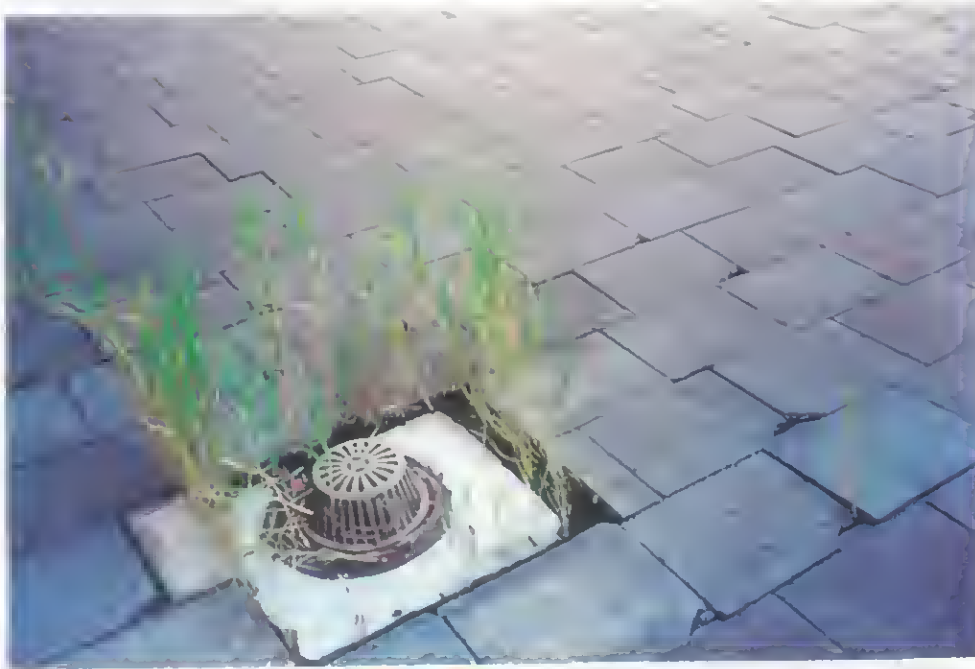
**Photograph 13**

Detail of roof  
drain with  
vegetation  
growth  
supported by the  
moisture held in  
paver backing

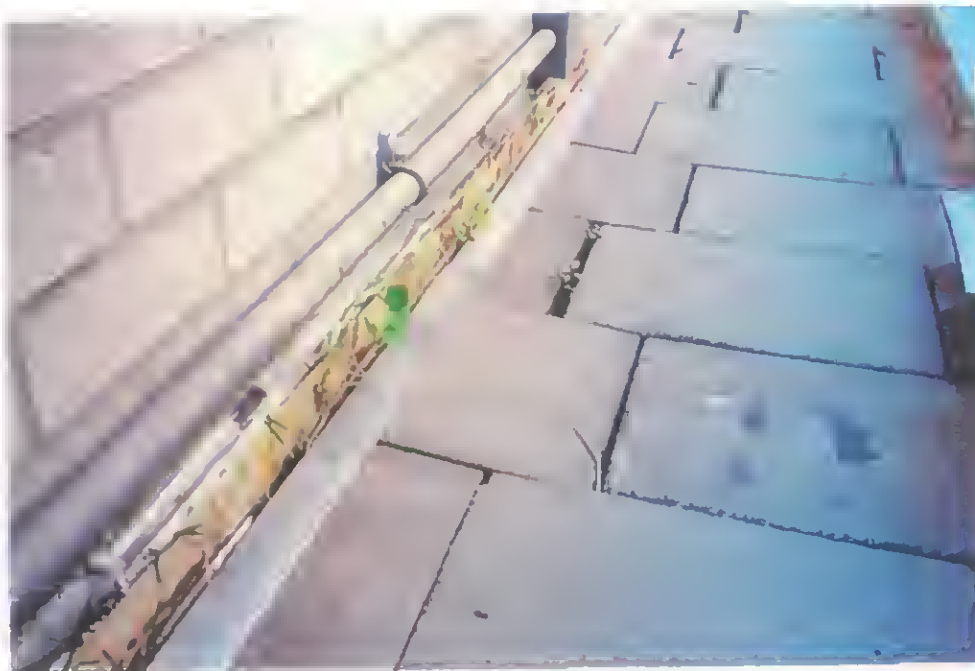
**Photograph 14**

Detail of  
perimeter  
flashing detail  
with vegetation  
growth

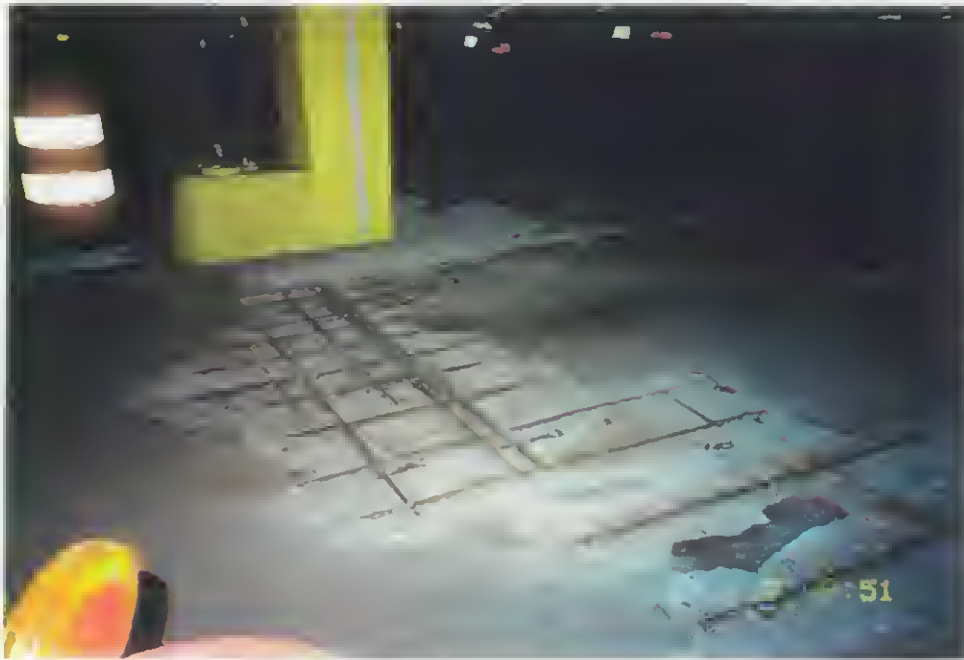
Photograph 7

Spalling garage  
slab - Level 2, North

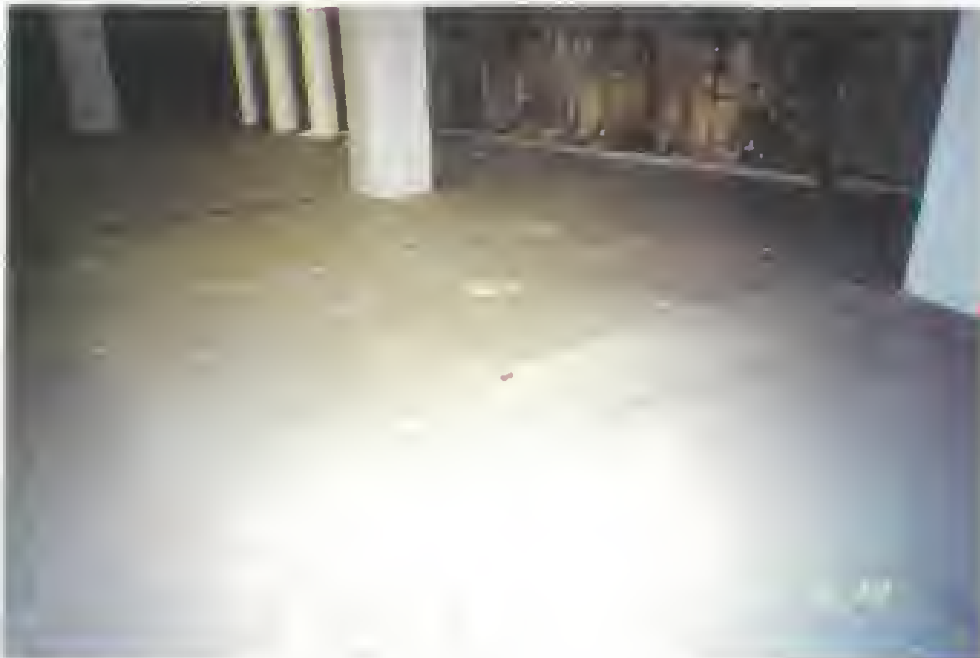
Photograph 8

Spalling slab in B5  
Central Plant

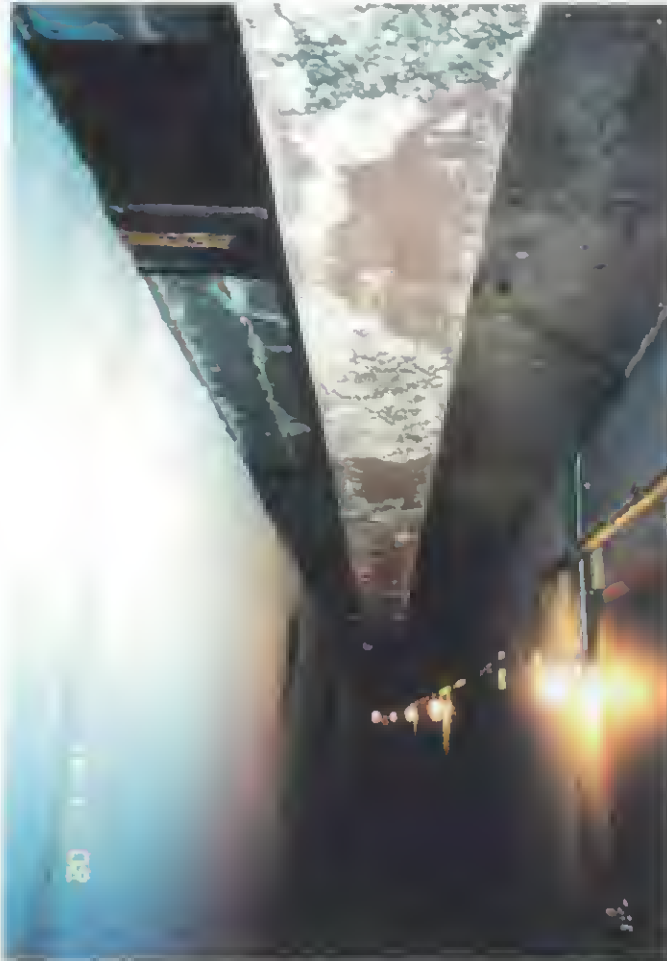
**Photograph 13**

**Missing fireproofing  
at ventilation  
plenum - B2 North**

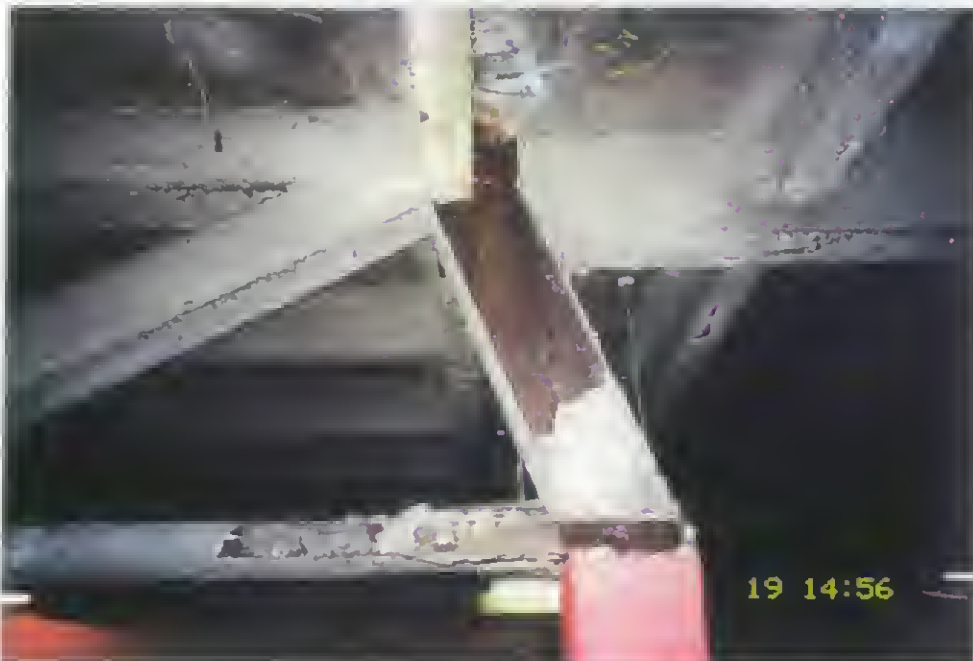
**Photograph 14**

**Missing fireproofing  
at B-2 Garage**

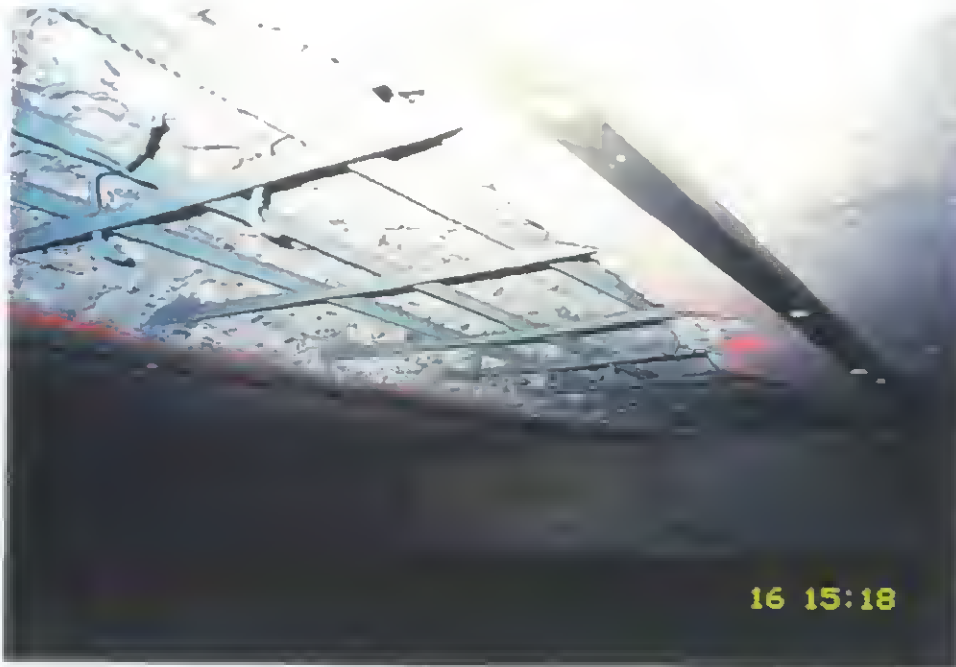
Photograph 19

Ceiling under B4  
ramp (south) in  
ventilation plenum  
requires repairs

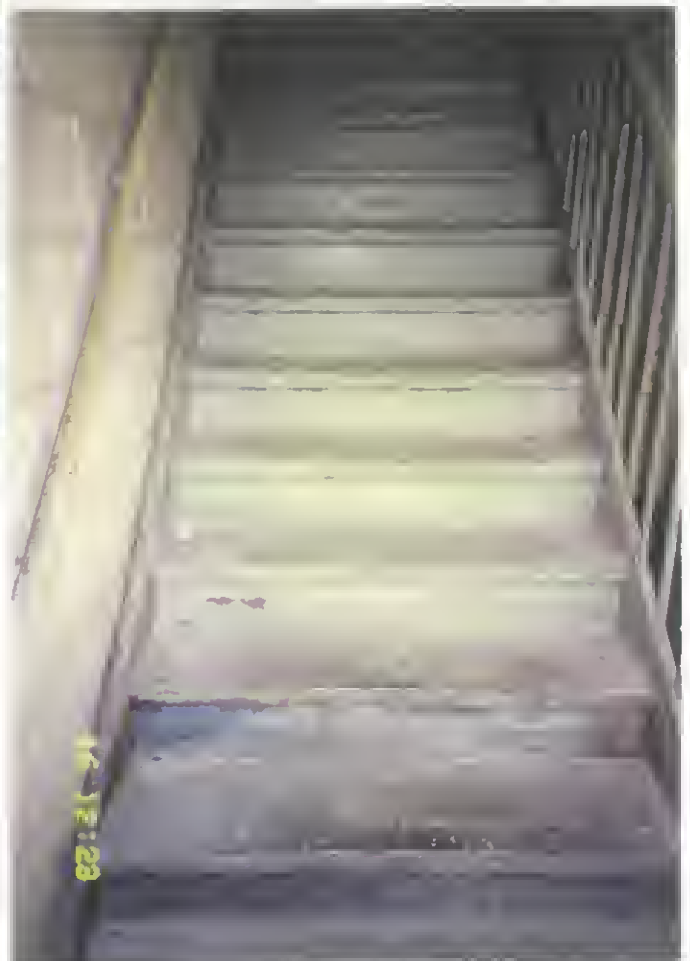
Photograph 22

Typical subgrade  
stair requires  
cleaning and  
some require  
painting

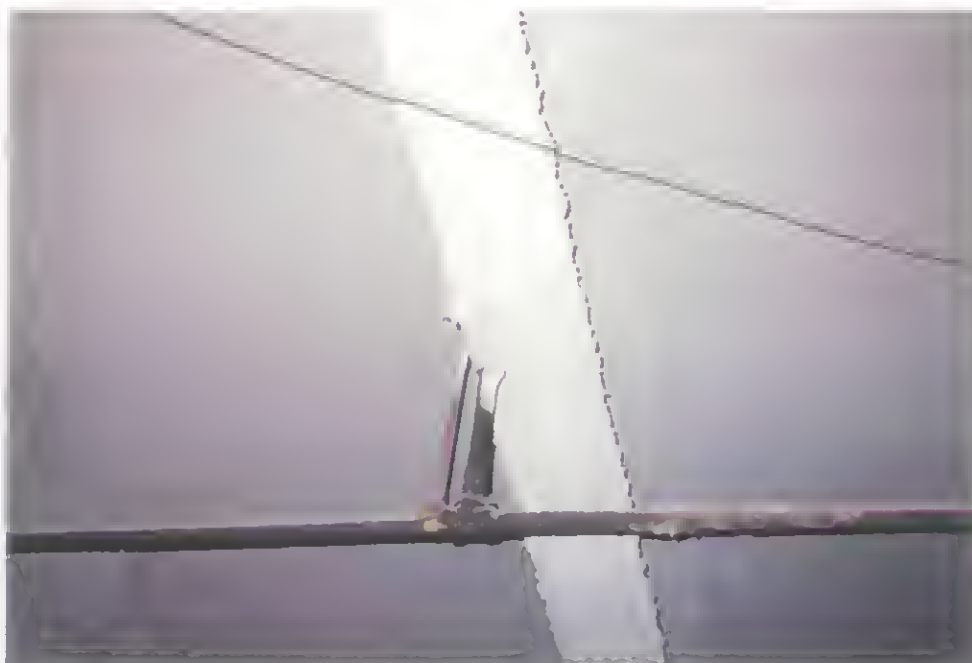
Photograph M14

Sprinkler head in  
the loading dock  
area observed to be  
painted
